INTERSTATE COMMERCE COMMISSION

REPORT OF THE DIRECTOR OF THE BUREAU OF SAFETY CONCERNING AN ACCIDENT ON THE CLEVELAND, CINCINNATI, CHICAGO & ST. LOUIS RAILWAY AT WORTHINGTON, OHIO, ON NOVEMBER 16, 1933.

Inv. No. 1866 Cleveland, Cincinnati, Chicago & St. Louis Ry. Worthington, Ohio November 16, 1933.

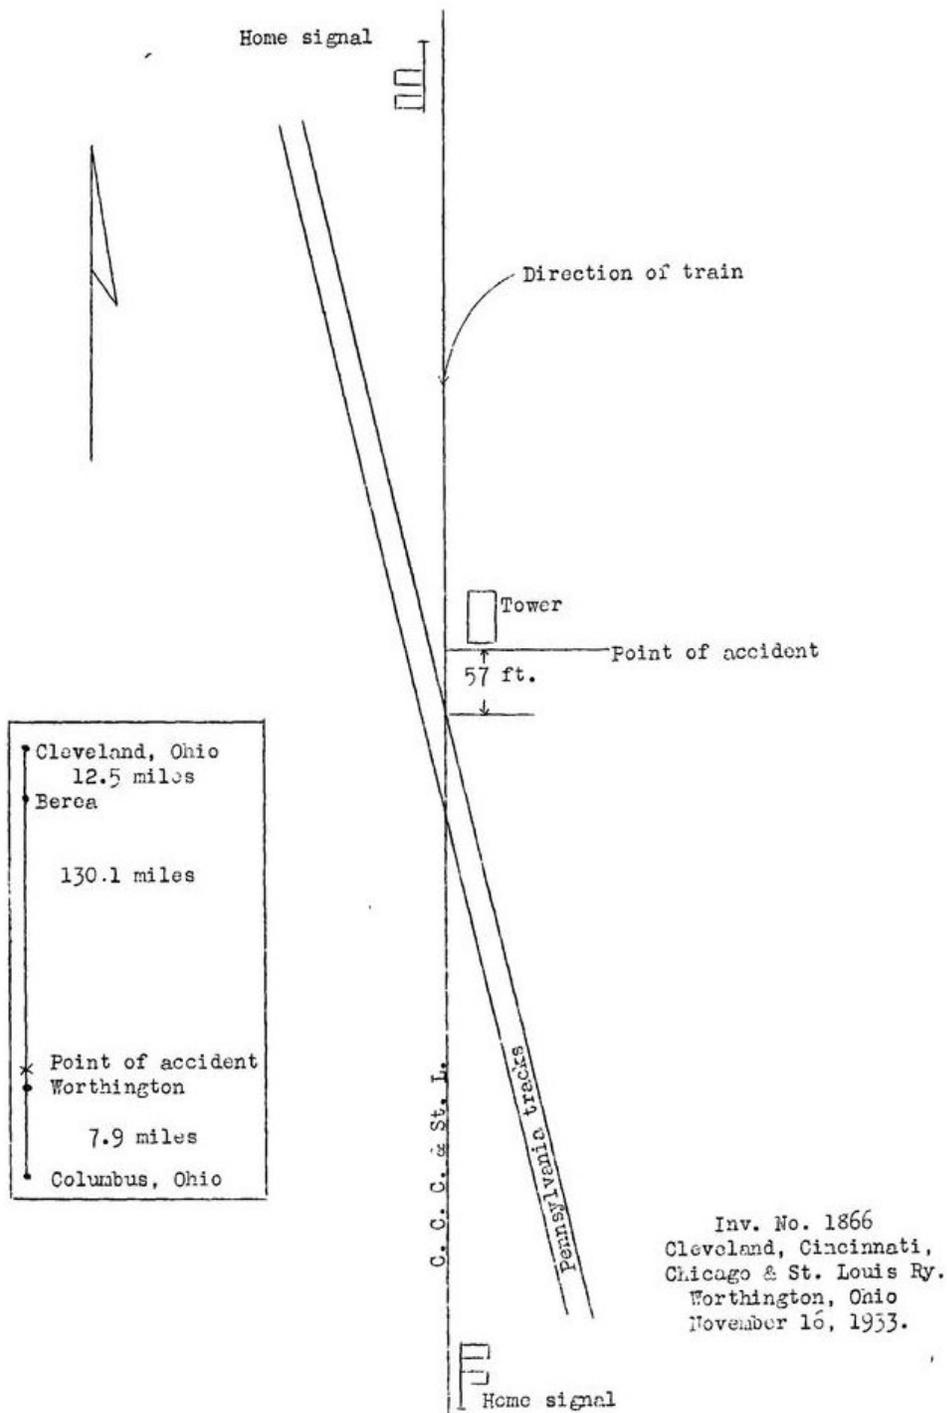
[Diagram](#)

The seven rear cars were derailed to the left and stopped in various positions in a shallow ditch between the crossing and the east-bound home signal, within a distance of about 600 feet. The

The rail involved was on the left or south side of the track, breaking at a point about 57 feet east of the center line of the first of the Pennsylvania tracks; this rail broke into many pieces, some of it being shattered, and about 7 feet of it could not be found. The breaks ran in various directions, some diagonally through the ball and web to the base, while other breaks ran horizontally; all of the breaks were fresh and there were no indications of fissures. The rail showed extreme hardness and much wear, and the base and web were both very thin. Under date of December 20, 1933, Superintendent Gegenheimer of the Pennsylvania Railroad advised that the rail had been sent to Altoona, Pa., for testing, but at the time of this report no information relative thereto has been received.
