BUREAU OF SAFETY

REPORT NO. 1958

### REPORT OF THE DIRECTOR OF THE BUREAU OF SAFETY CONCERNING AN ACCIDENT ON THE PENNSYLVANIA RAILROAD AT LINDEN, OHIO, ON DECEMBER 27, 1934.

February 21, 1935.

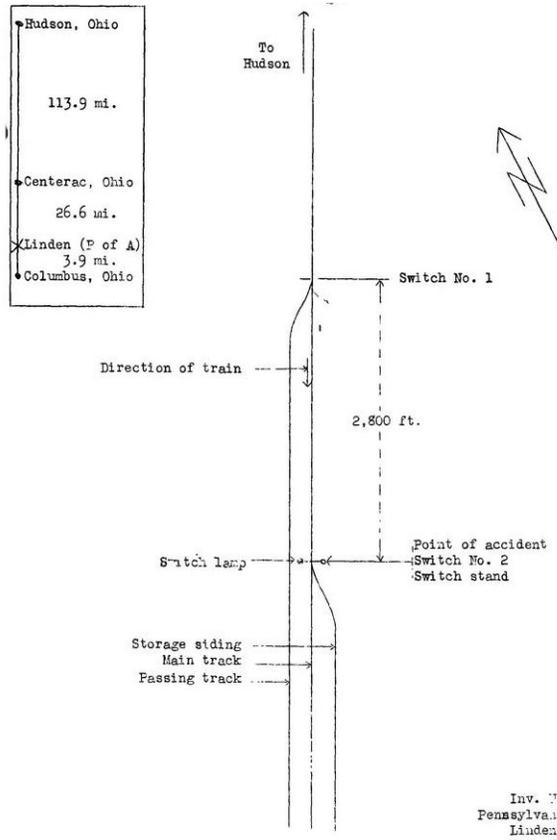
Inv. No. 1958  
 Pennsylvania Railroad  
 Linden, Ohio  
 Dec. 27, 1934

The north storage switch is known as switch No. 2 and is a facing-point switch for south-bound train, with a No. 10 turnout, and leads off the main track to the left to the storage siding, which parallels the main track on the east. On the opposite side of the main track there is a passing track, the north switch, known as switch No. 1, being located approximately 2,800 feet north of switch No. 2. The low switch stand of switch No. 2, of the New Century type, is located on the east side of the track, with an auxiliary stand located between the main track and passing track upon which is mounted a switch lamp, the center of the lamp being slightly above the level of the rails of the main track. The lamp stand has flared reflector discs which serve in place of targets for day indications; normal indications are red when the switch is open and green when closed. At the time of the accident there were box cars on the north end of the storage siding.

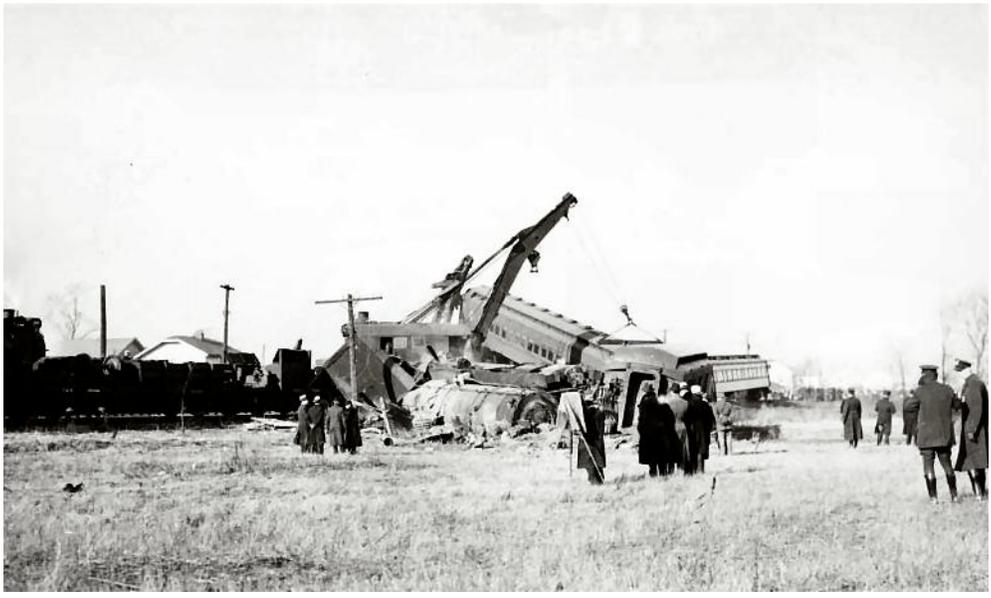
The entire train was derailed, engine 7211 stopping on its right side, east of the tracks and headed Southeast, with its front end 366 feet south of the switch points; the tender was behind the engine and on its left side. The cars stopped at various engine to the track but all of them remained upright. The derailed equipment struck box cars standing on the storage siding and damaged four of them, the first two being practically demolished. The employees killed were the engineman fireman, and a road foreman of engines; the employees injured were the conductor and brakeman.

Locomotive and tender on their side after the 1934 PRR wreck at linden north of Columbus Ohio. Photo gleamed from the Northeast Rails web site - <http://www.northeast.railfan.net/>
