INVESTIGATION NO. 3187

UNION DEPOT COMPANY

THE BALTIMORE AND OHIO RAILROAD COMPANY AND THE PENNSYLVANIA RAILROAD COMPANY REPORT IN RE ACCIDENT AT COLUMBUS, OHIO, ON JUNE 7, 1948

August 3, 1948

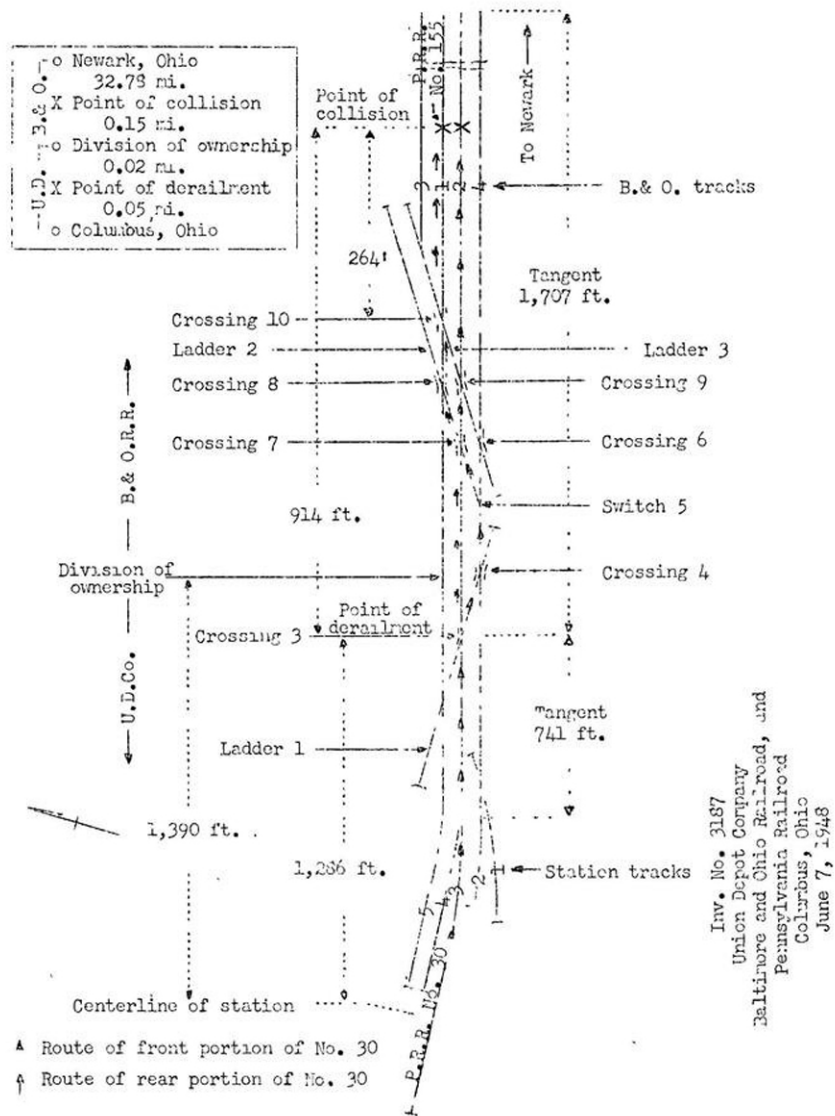
Inv. No. 3187 Union Depot Company Baltimore and Ohio Railroad, and Pennsylvania Railroad Columbus, Ohio June 7, 1948

For a track diagram see below
